## Inspection Report Minerals Regulatory Program June 10, 2010

<b>Mine Name:</b> New-6	<b>Permit Number:</b> S/027/0111
<b>Operator Name:</b> Alan Newman	<b>Inspection Date:</b> 05/13/2010
<b>Inspector(s):</b> Brett Gregory for John Rogers

<b>Time:</b> 1:00 pm
<b>Other Participants:</b> None	<b>Mine Status:</b> Abandoned

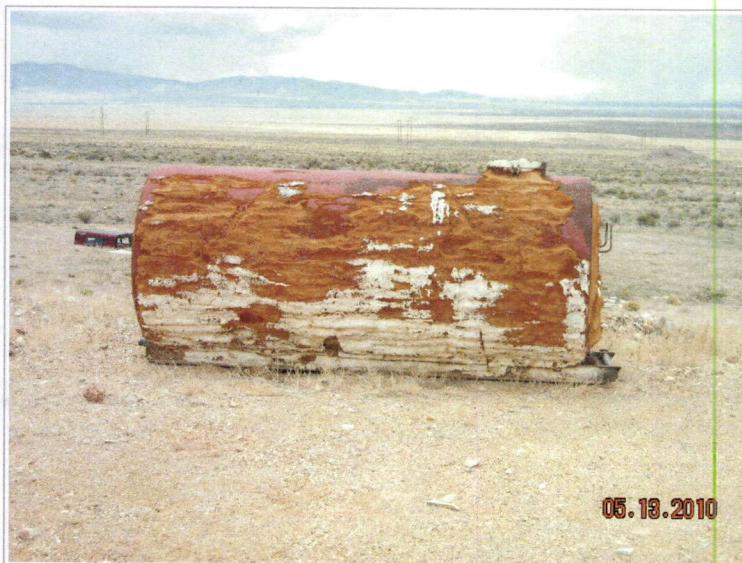
Fuel tank on skids. (Salvage value unknown?)

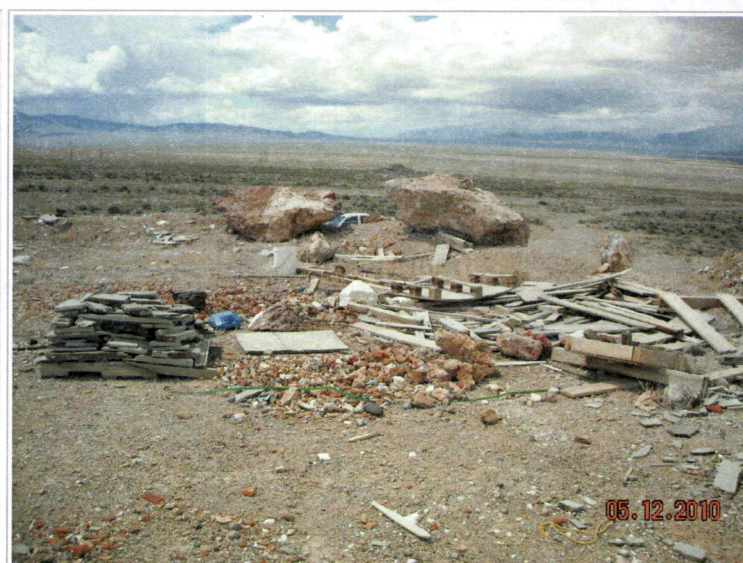
Broken pallets and trash to be cleaned up.

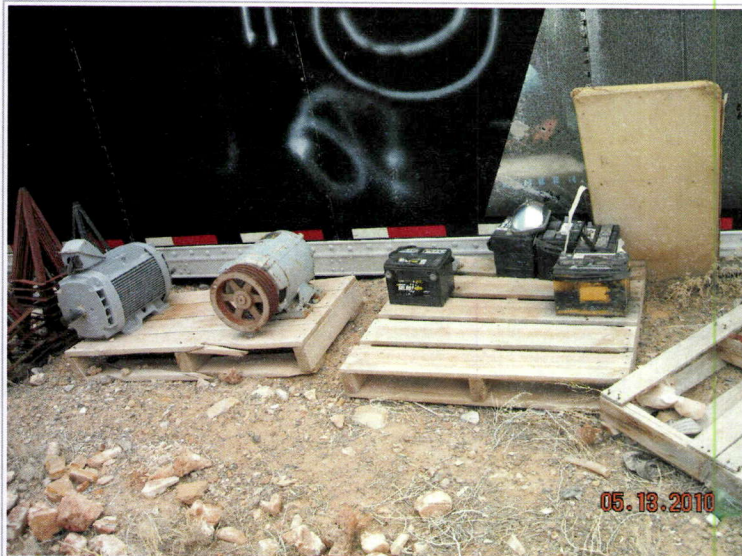
Motors and batteries that need to be salvaged or disposed of properly.

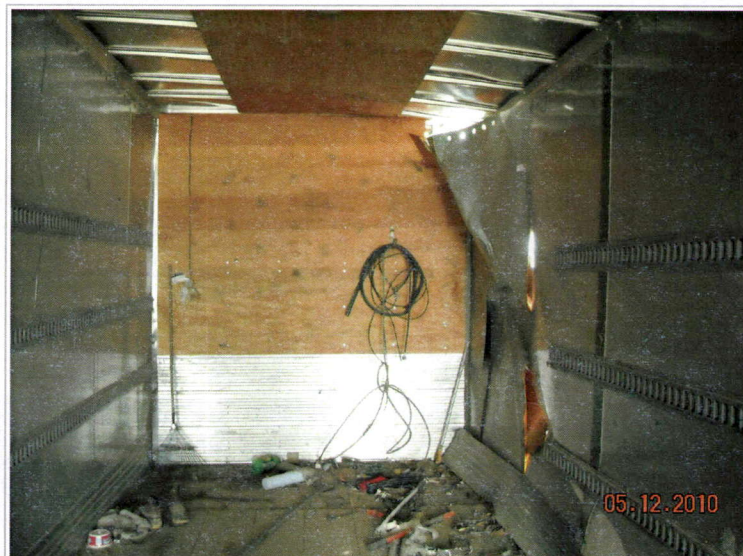
Semi-trailer in disrepair. (Possible salvage value uncertain?)

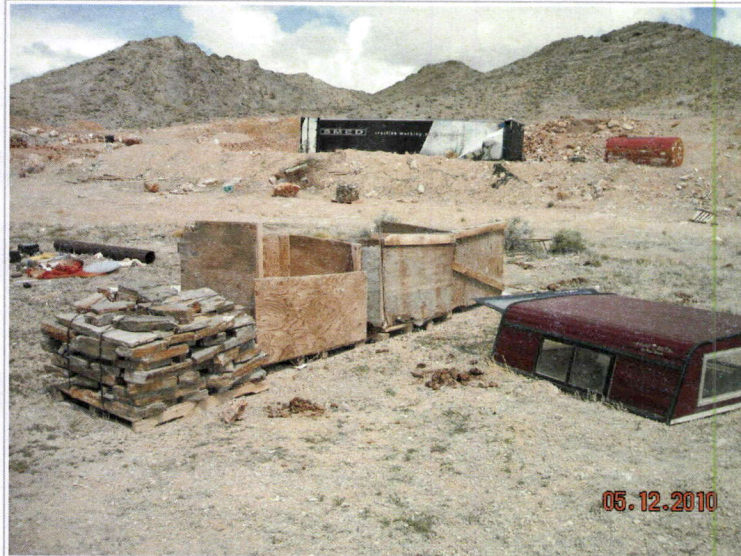
Various cleanup items. (The trailer and fuel tank could potentially be salvaged to recoup reclamation costs.)

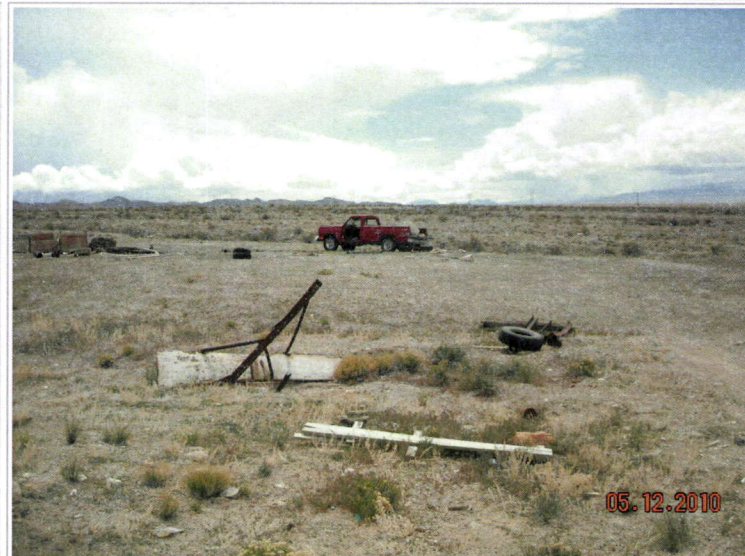
Stripped truck and minor garbage that needs to be disposed of.

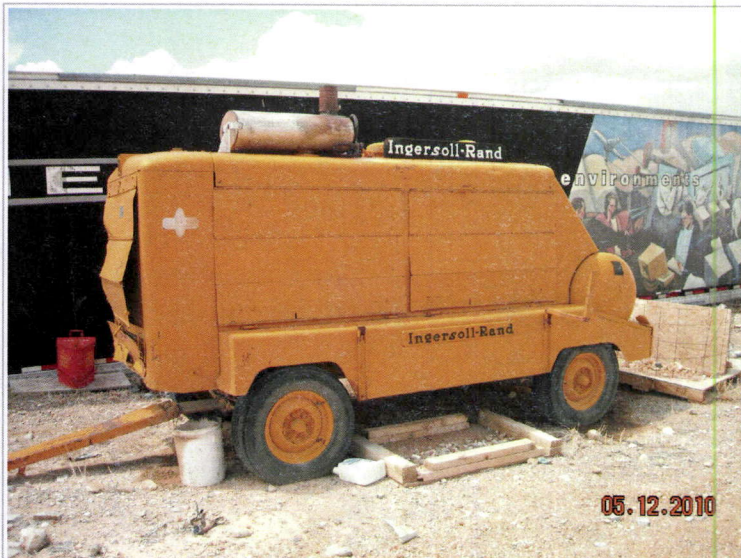
Auxiliary booster or compressor. (Equipment potentially salvageable?)

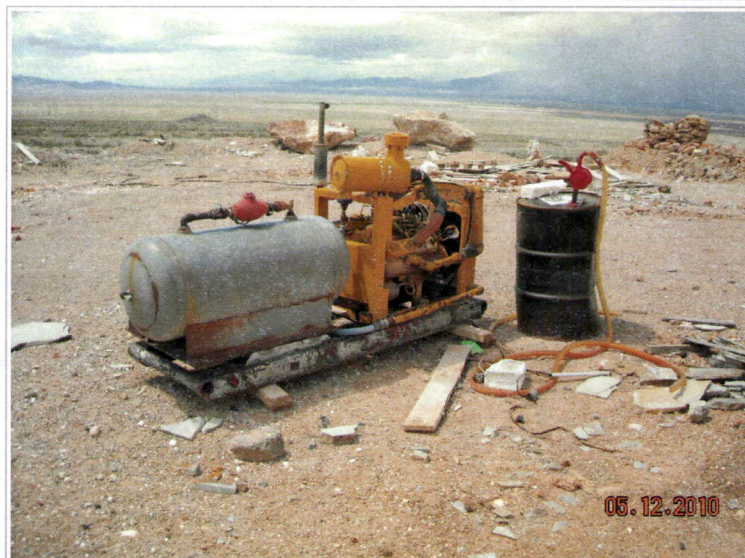
Skid mounted engine with air tank. (Equipment potentially salvageable?)

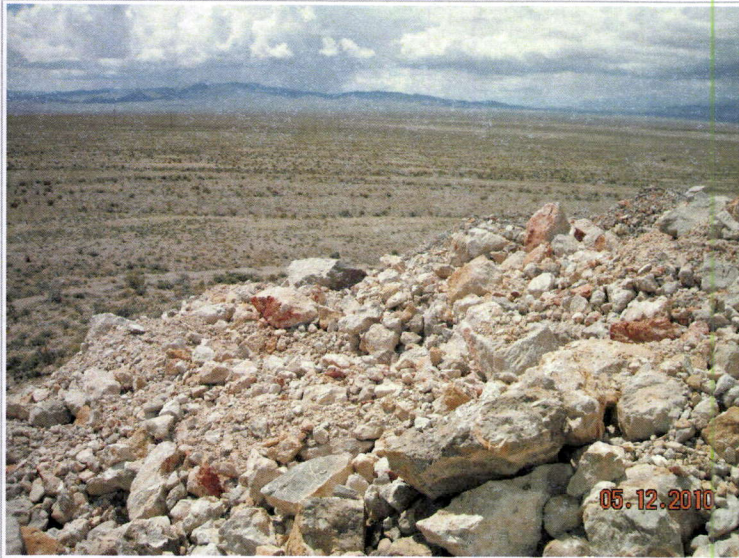
Assorted aggregate. (i.e. overburden)

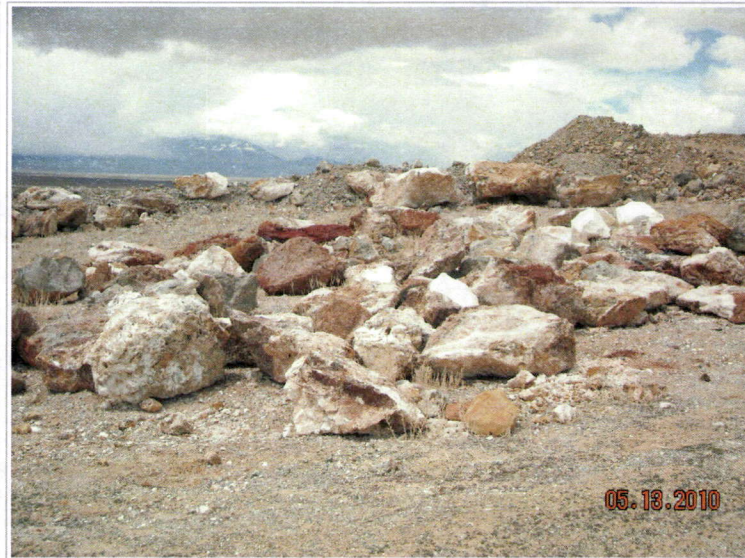
Boulder material. (Value unknown?)

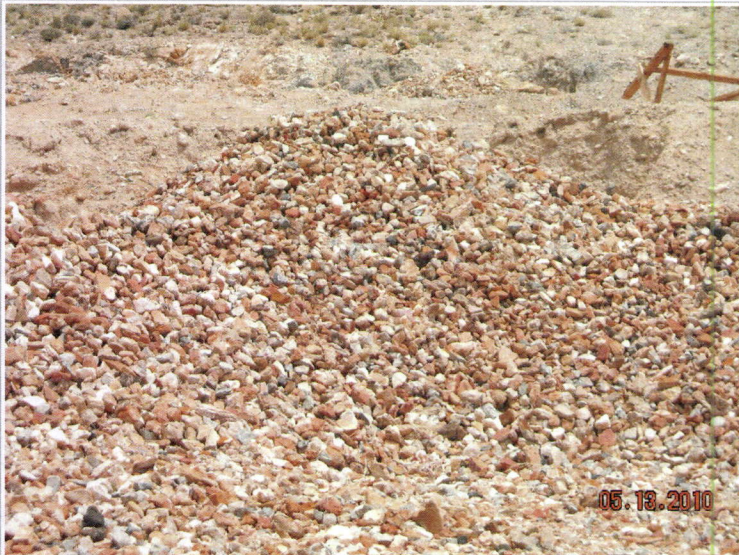
Cobble material. (Value unknown?)

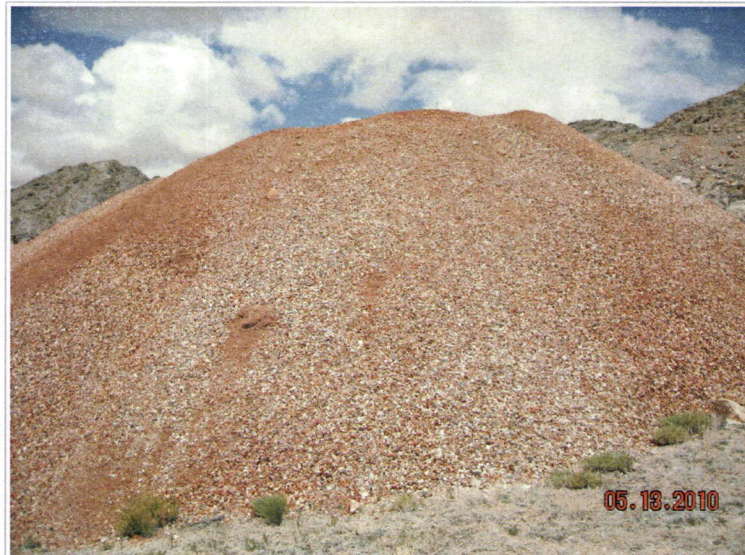
Gravel material. (Value unknown?)

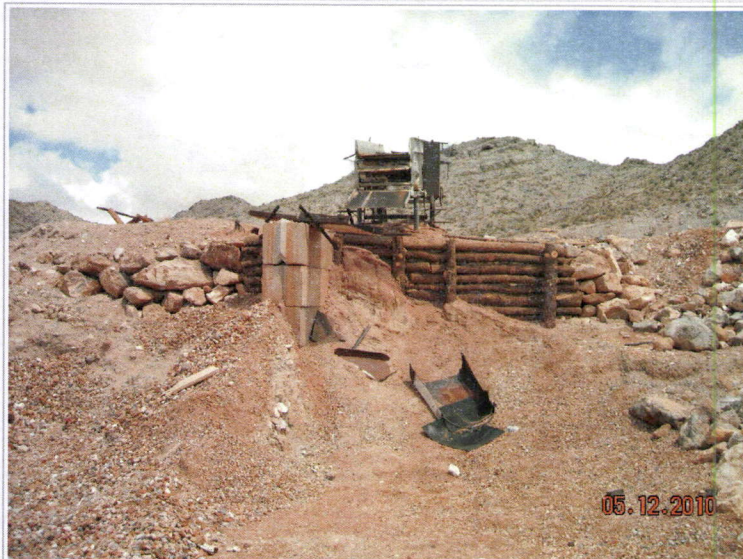
Dilapidated load-out facility. (Reclamation recommended!)

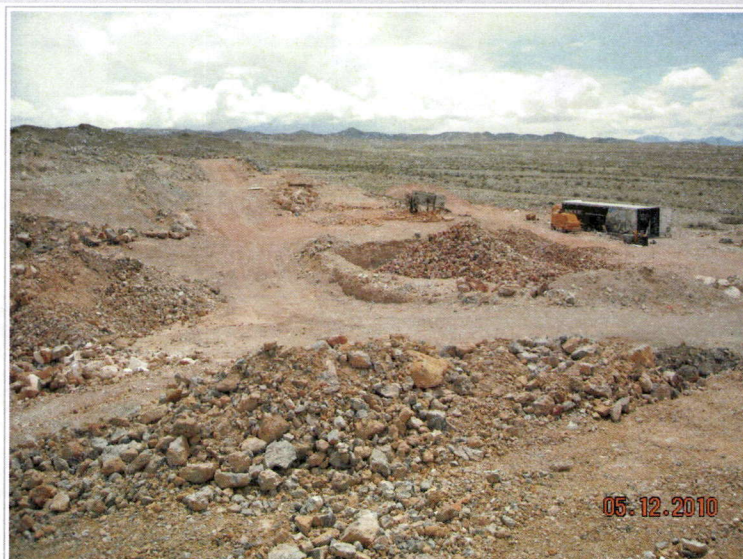
Variable road disturbance looking south. (Reclamation recommended!)

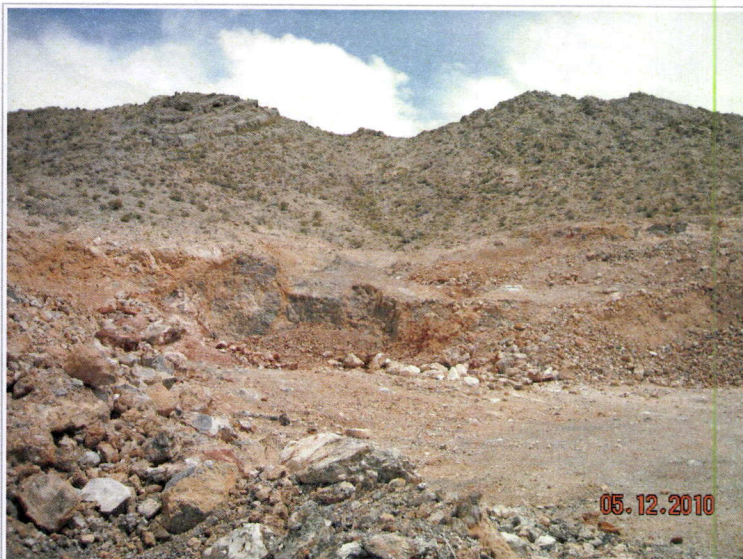
Northern mining disturbance. (Reclamation recommended!)

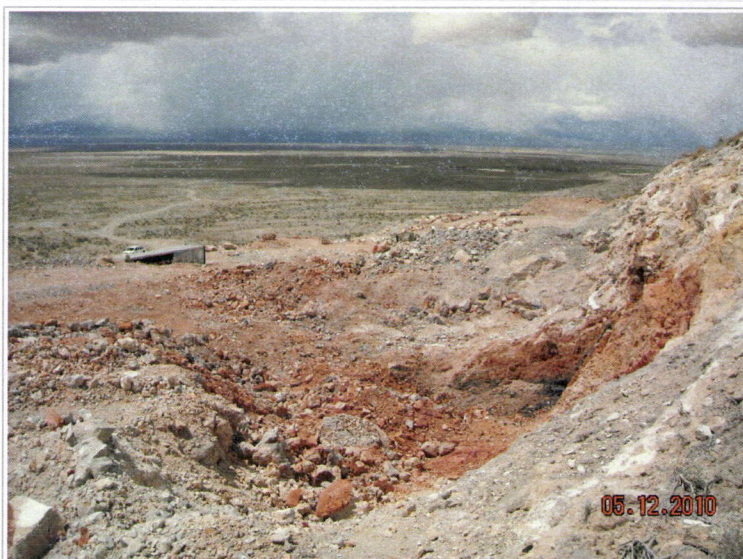
Southern disturbance. (May have community pit potential?).

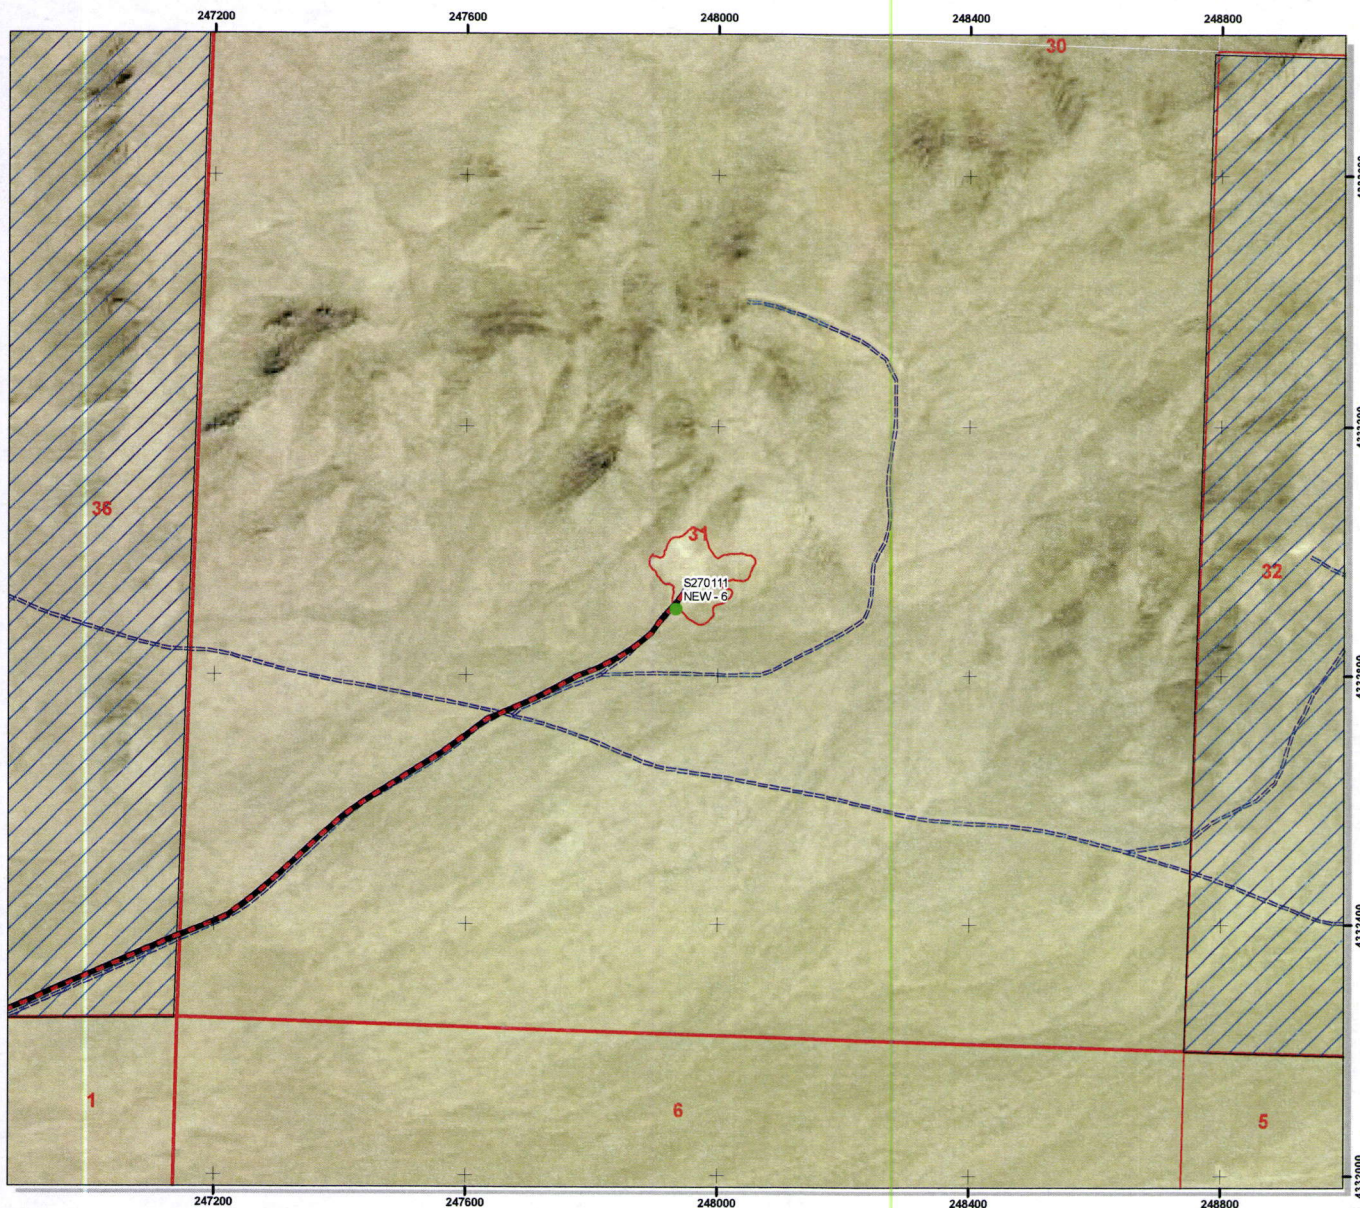
**Mine Number: S270111**  
**Mine Name: NEW - 6**  
**Township 19.0 S Range 18.0 W Section 31**  
**Meridian: SLBM**

- 6) The GPS data indicates the mining footprint is larger than the approved 3 acres in the permit.
- 7) The graded stockpiles of material should be buried or otherwise removed from the site if no further mining is to be done.
- 12) Photographs and a GPS map are enclosed in this report.

Acres Disturbed	3.28
Acres Regraded	0
Acres Seeded	0
Road Acres Disturbed	0

Total Acres Disturbed 3.29

The operator must do the following to retain an active mining permit: (1) pay past due annual permit fees, (2) post the recommended additional surety of \$8,600 dollars, (3) dispose of any trash and dilapidated equipment, (4) partially reclaim or amend the Notice of Intension (NOI) to reflect 4 acres of disturbance, and (5) comply with any directives the Bureau of Land Management (BLM) may have to reclaim the site.
